# **Step-by-step investigations and remedial actions at a former industrial dry cleaner in Boden, Sweden. Lessons learned.**

NORDROCS 2026, Helsinki  
Session J  
16 September

# The former industrial dry cleaner in Boden

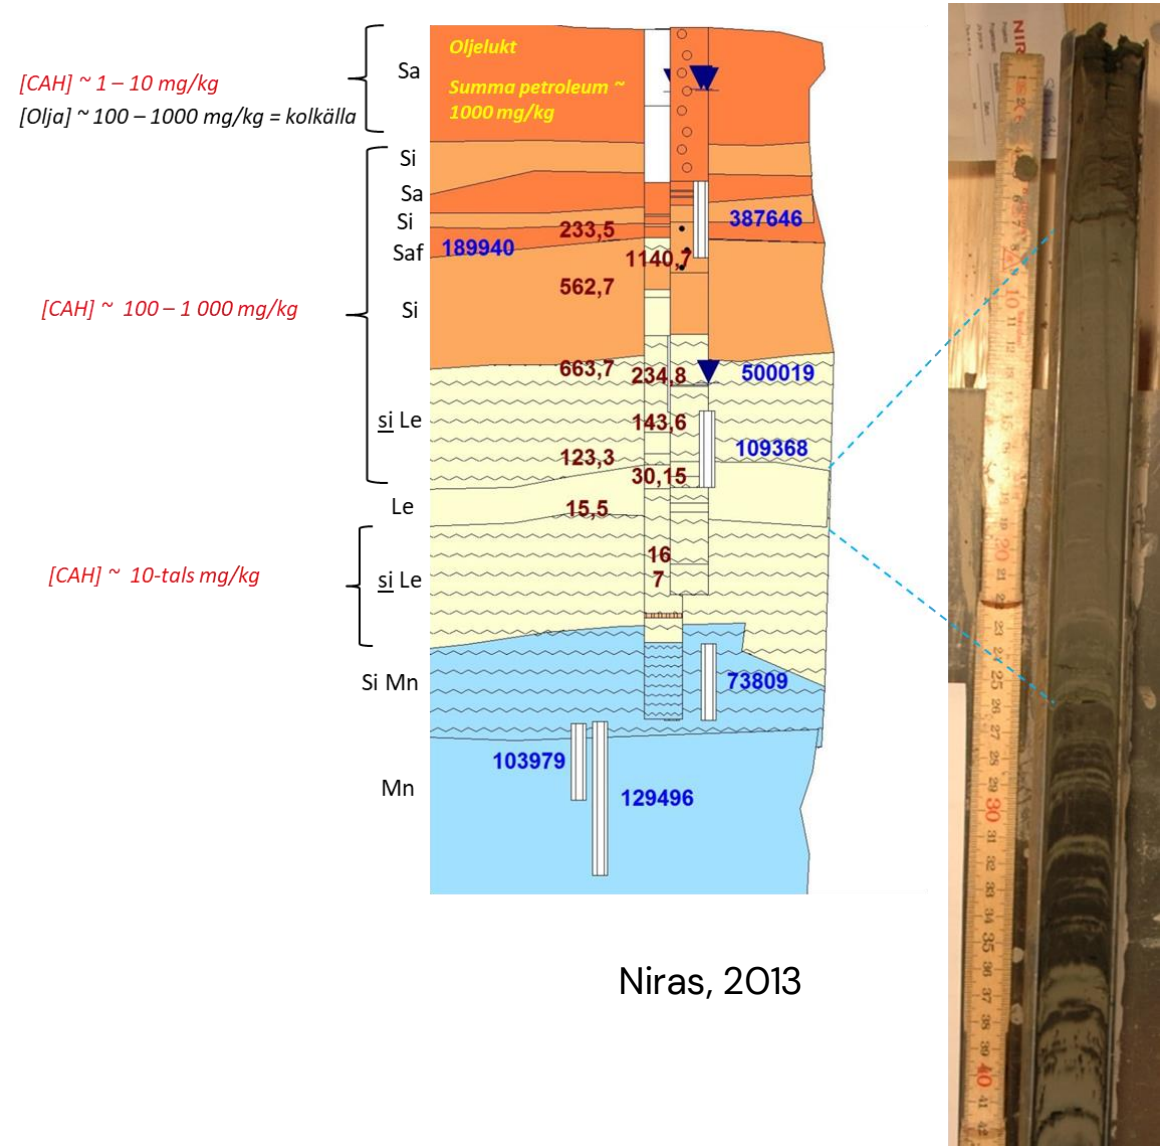
10 x 10 m test area.

Detailed characterization with  
MIP probing and soil coring

Complex soil conditions  
Vertical leakage through clay  
layers

Injection of ZVI and carbon  
source

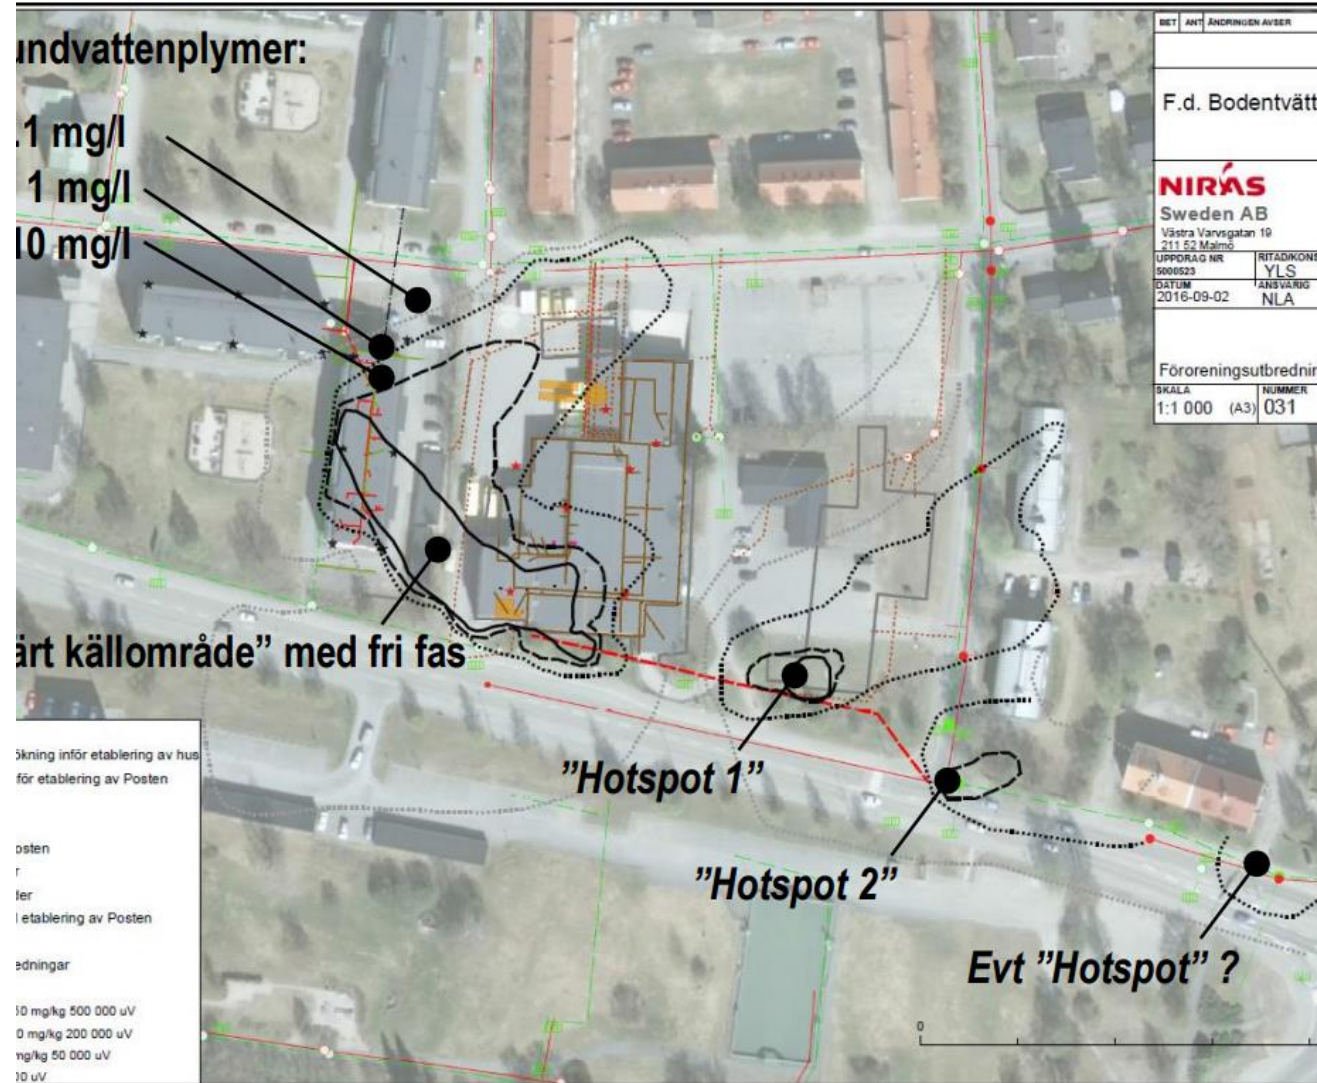
**More than 2 new hot spots!**

Leakage from the utility pipe at 3 points

Shallow groundwater flow towards the NE

At Hot spot 1 old piles had caused a deeper migration.

Also next to Hot spot 2 the clay layers had been perforated.

At Hot spot 2 the utility pipe was connected to the municipal sewer system.  
Possible additional hot spots

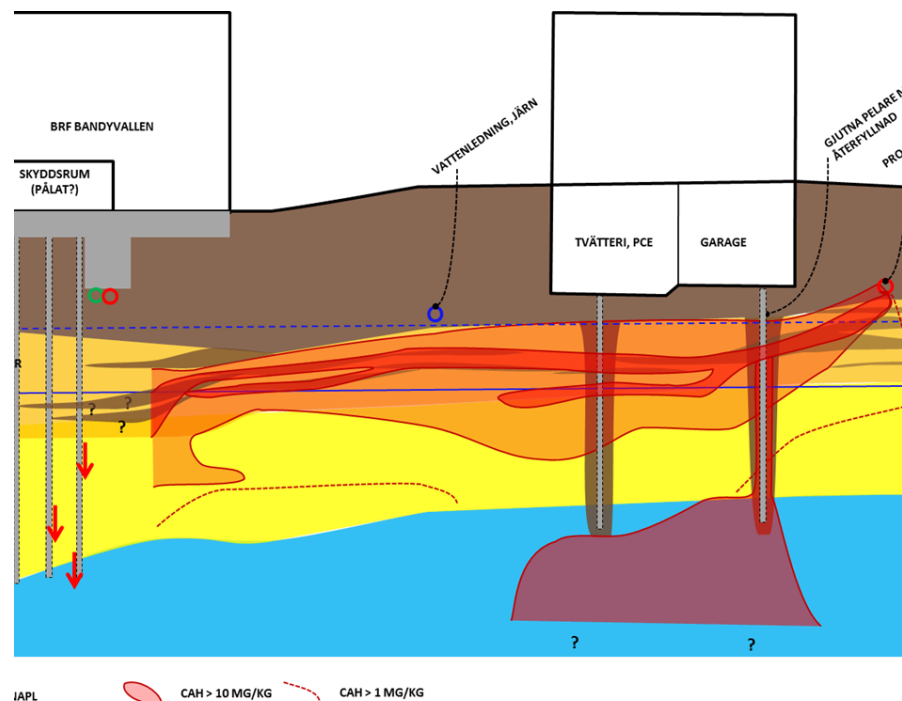
A continuous clay layer in the area (yellow)

A horizontal distribution of DNAPL (red) under the building

Extensive vertical migration of PCE to the underlying moraine (blue)

The PCE mass in the underlying moraine is large.

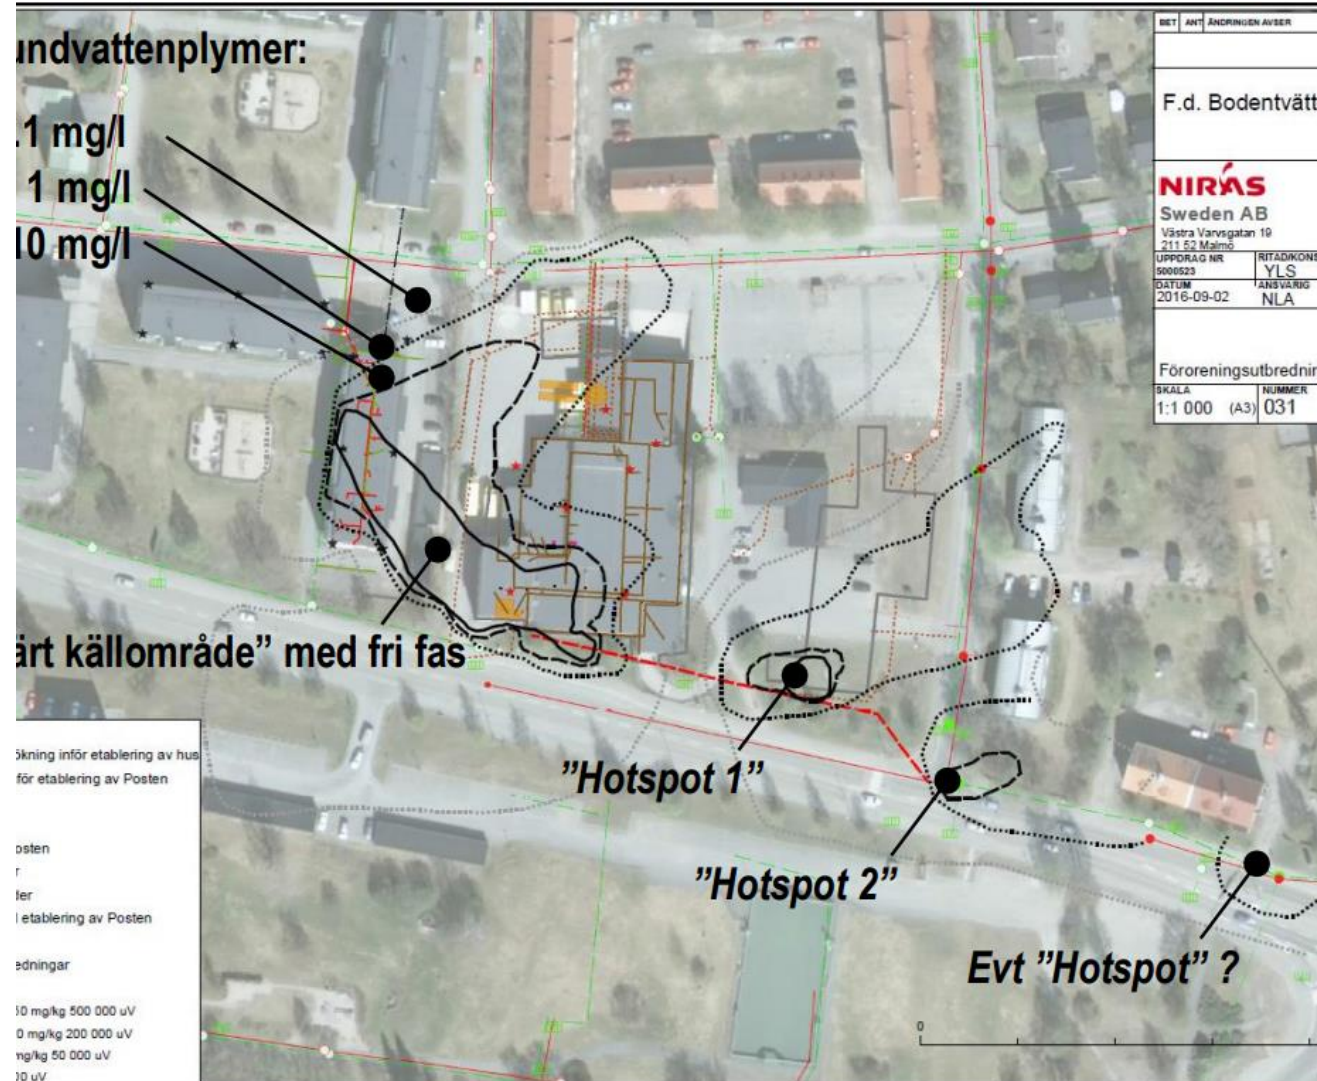
CVOC gases in indoor air in adjacent residential buildings.

- Below threshold values in the houses to the east. Highest concentrations 2 floors up!
- In the adjacent western building exceeding PCE gas concentration on the first floor, only.

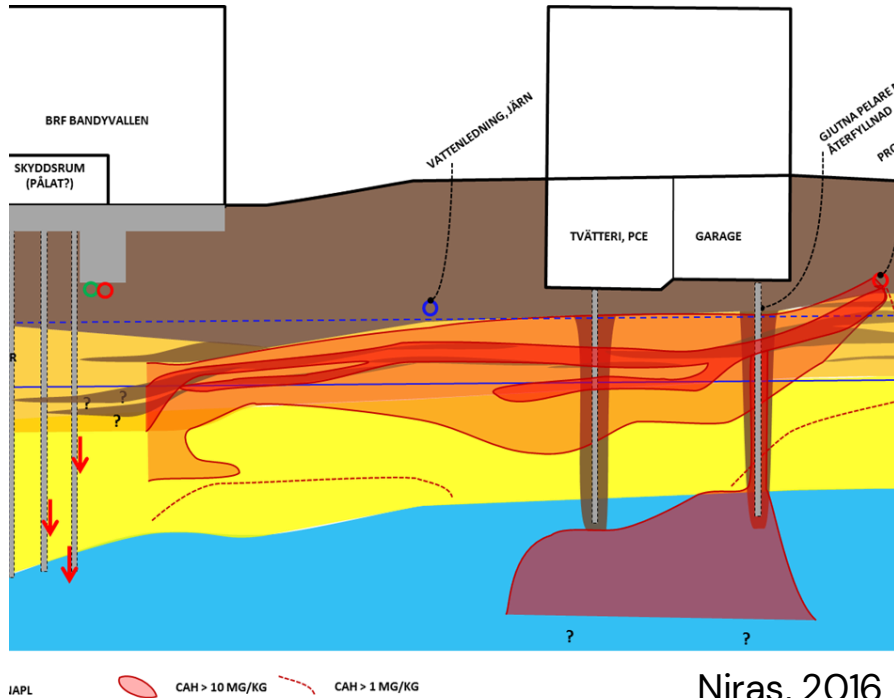
- A continuous clay layer exists in the area
- A downward gradient from the upper soil layers
- No existing groundwater extraction in the moraine.
- Moraine thickness up to 60 meters.
- None existing geoenery wells in the bedrock in the area.
- Estimated CVOOC flux in the moraine to the nearest surface water is not significant.

- The deeper contaminants possess no health and nor environmental risk.

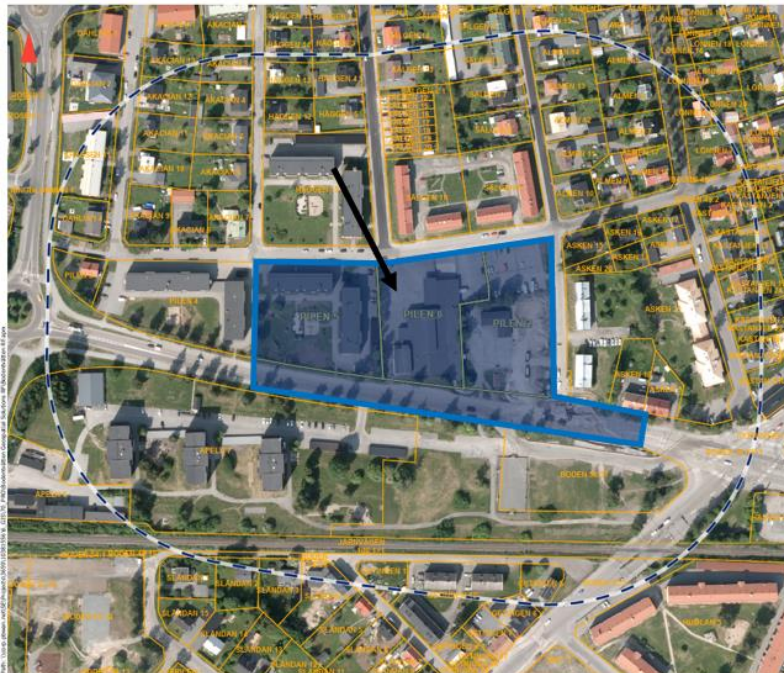
This contamination means no risk to health or the environment with present land use

Establish areas subject to land-use restrictions

In the blue area:

- Any piling and drilling is prohibited
- restrictions on deep groundwater lowering in the upper soil layers

Within a 150 m radius:

- Drilling for the installations of geothermal heating is prohibited.
