# THE AVENUE COKING WORKS REMEDIATION

Stany Pensaert, Peter Van den Bossche

## Abstract

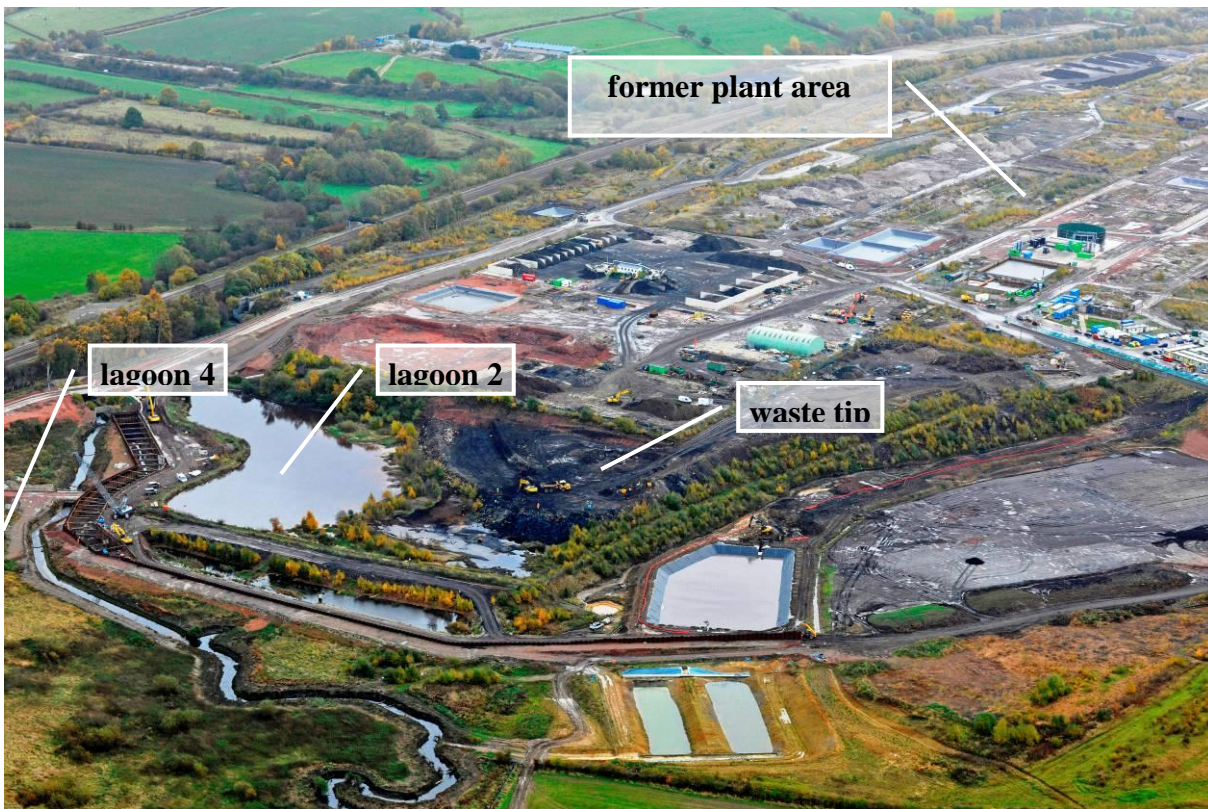
Three typical polluted areas can be found on the site: the two lagoons that store heavily polluted sludges, the waste tip, and the former plant area. In the waste tip all solid waste of the plant was tipped during many decades. This waste comprises soil, ashes, cyanide infected timber, asbestos gaskets,... The lagoons were infilled with heavily polluted sludges from the various processes on site, and contain high amounts of tar, ammonium, sulphate, gypsum, lime,... Figure 1 below shows the various areas on the site.

Figure 1. Overview of the site.

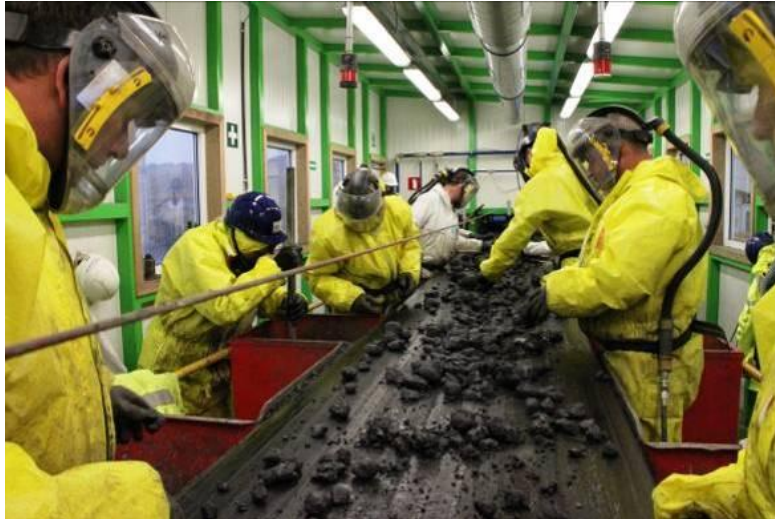
The trials of 2006 confirmed the design of the operation. The operation is required to remove the items that cannot be incorporated into the final landform. A screen splits the waste-tip material into 3 size fractions. The small fines fraction is relatively free of deleterious material and is, after screening, stockpiled and tested to determine whether it is fit for reuse or requires treatment. The largest fraction is subject to further sorting, screening and crushing as it contains concrete bricks, and belting, rags etc. The mid-size fraction goes through a picking station where items including asbestos bearing waste are manual sorted and removed from the stream. A final screen sorts the output of this stream. Gases volatilised at the screeners are subject to extractive carbon filtration. The workers in the picking station are fed fresh carbon filtered air as the environment within the picking station can be high in VOC's and there is an asbestos fibre risk.

The separated waste is collected in skips below the picking station and sent from off-site disposal.

Figure 2. The complex sorting in operation.

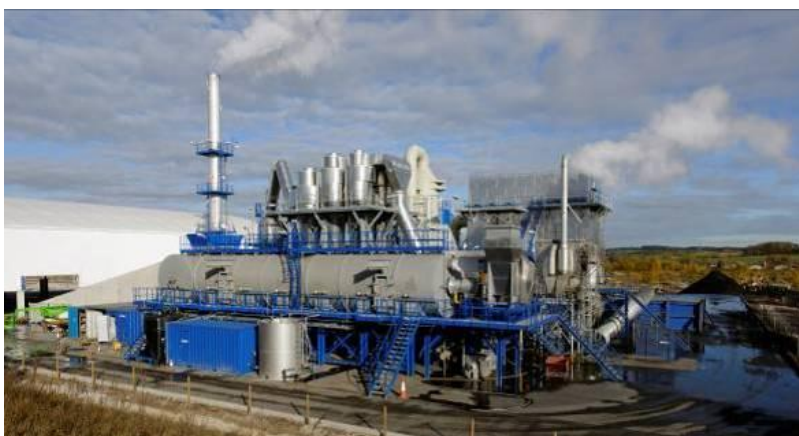
A thermal desorption plant was specially designed for this project, seen the volumes to be treated and the specific nature of the waste.

Highly contaminated lagoon sludges are mixed with drier and less calorific material to attain the appropriate calorific value and moisture content. The blended material is then processed through the 25t/hr kiln at temperatures in excess of 500°C to drive off all the organic contamination. As the off-gases are extremely loaded with various pollutants, including mercury, a special off-gas treatment system was designed for the plant.

Figure 3. The thermal desorption plant.
