NORDROCS 2026

# In-Situ Thermal Source Zone Clean-Up at the Nikro Site in Ylöjärvi, Finland

**Marcel Kolle · Mikko Kotro**

Nocon Remediation BV · Nordic Envicon Oy

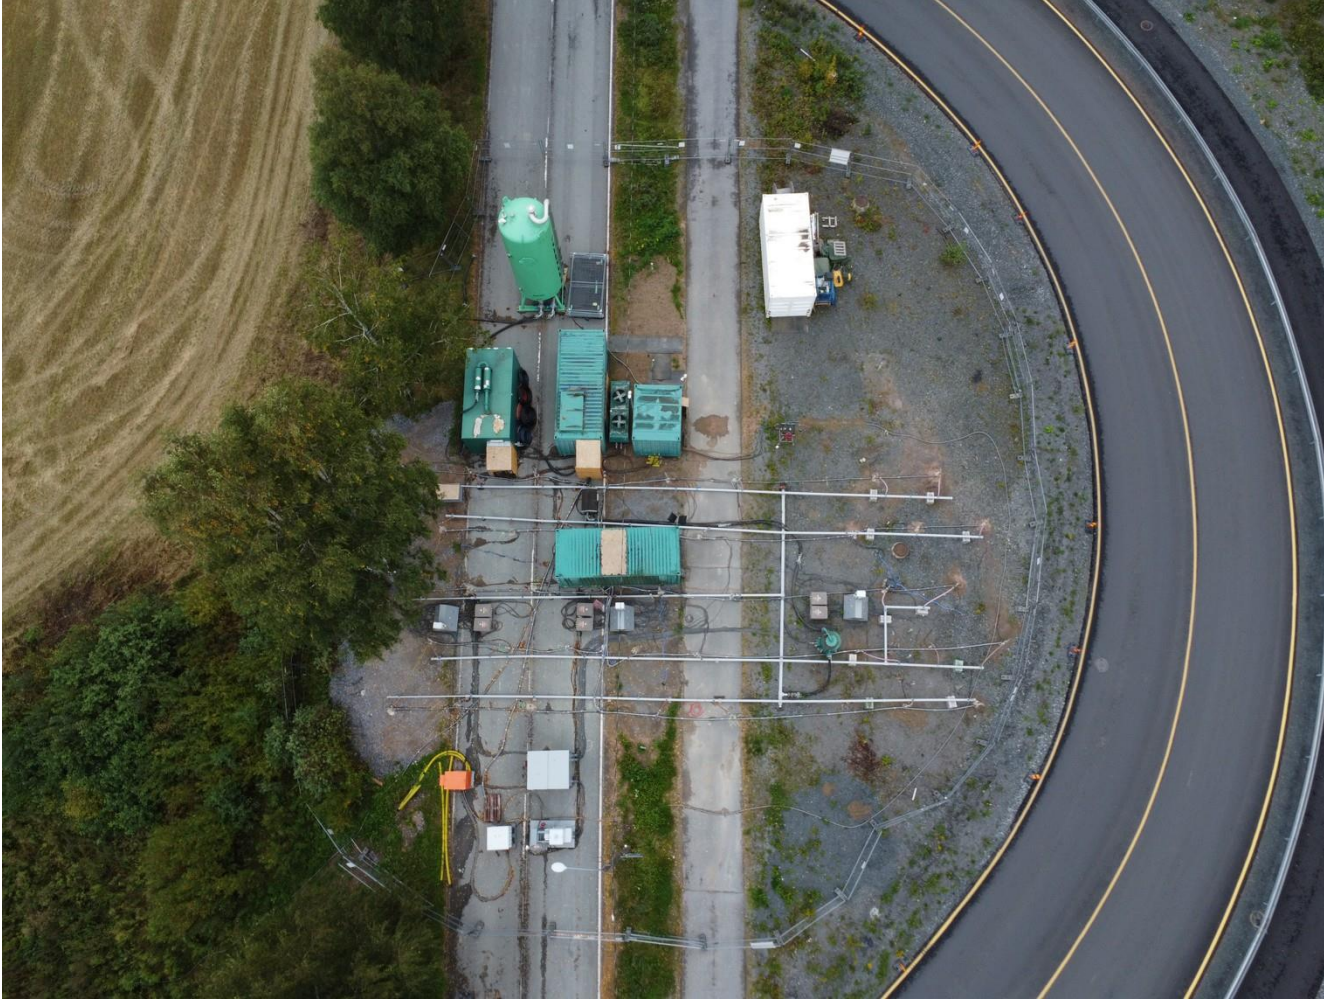
# Installations: temporary detour road

- Two-way vehicle lane, plus a cycle/pedestrian path
- Both surfaces asphalted with road markings

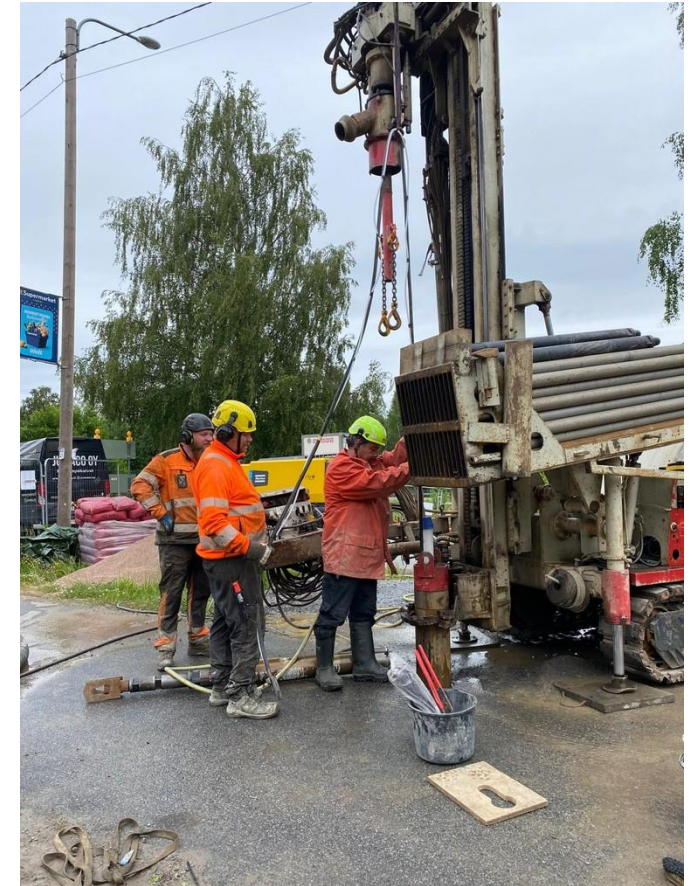
# Installations: electrode, temp. monitoring and GW wells

Electrode and SVE wells: 40 pcs

Temperature monitoring wells: 7 pcs

GW monitoring wells: 3 pcs
